**EXHIBIT A: PHOTOGRAPHS (API # 30-005-27971)**

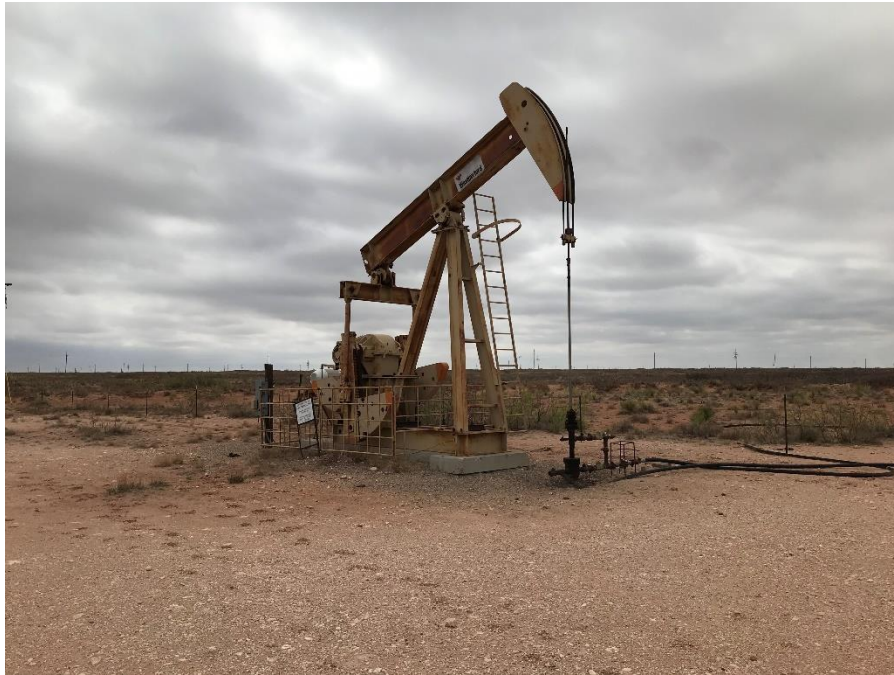
**Photo 1:** Cato San Andres Unit Well #504 viewed facing southeast approximately (SW4/SW4, section 02, T08S, R30E).

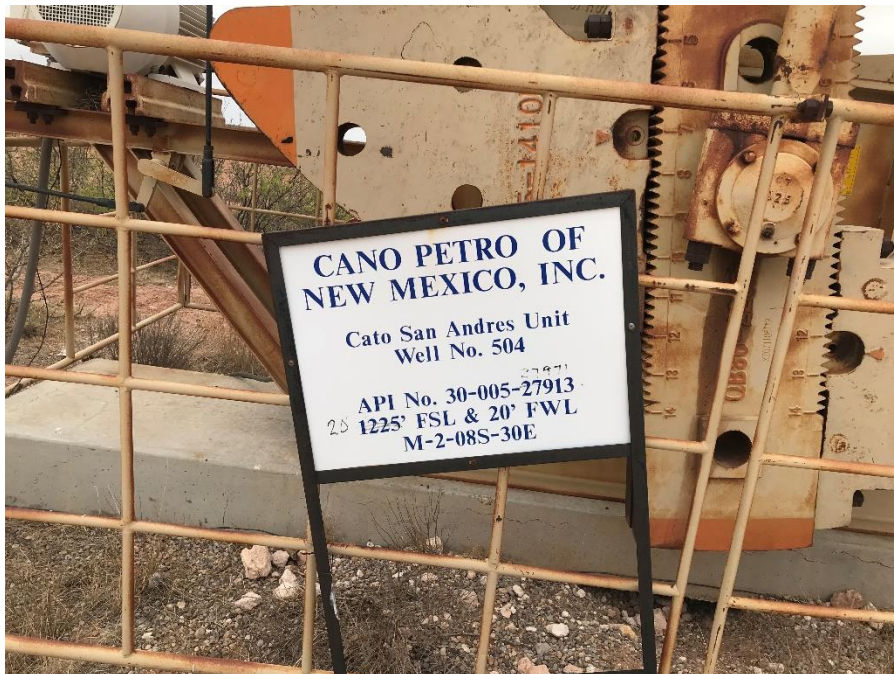
**Photo 2:** Close up view of sign identifying the well site.

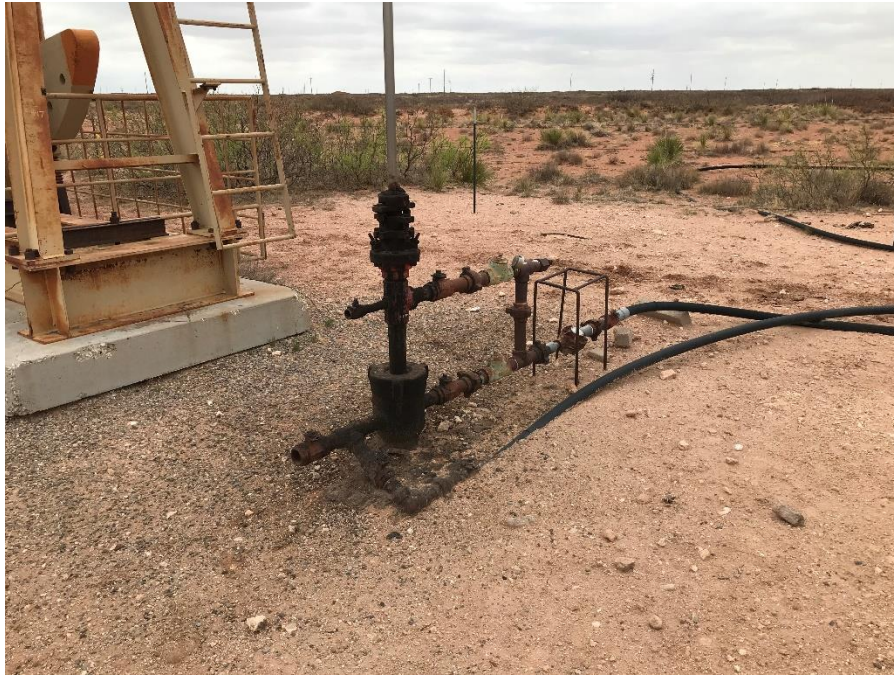
**Photo 3:** Close up view of the wellhead at the Cato San Andres Unit Well #504, staining is present (SW4/SW4, section 02, T08S, R30E).

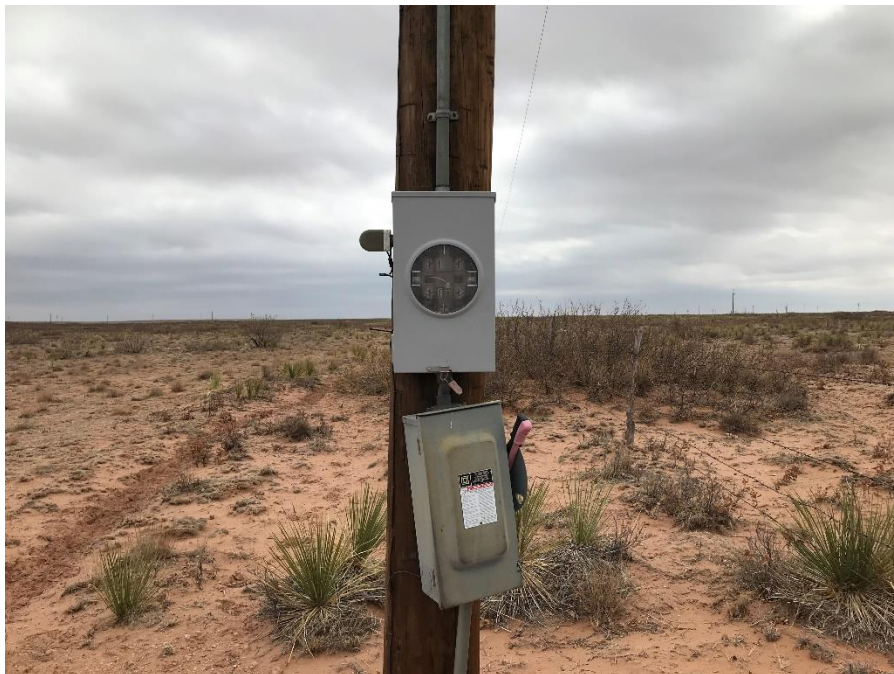
**Photo 4:** Broken electrical meter observed at the Cato San Andres Unit Well #504.

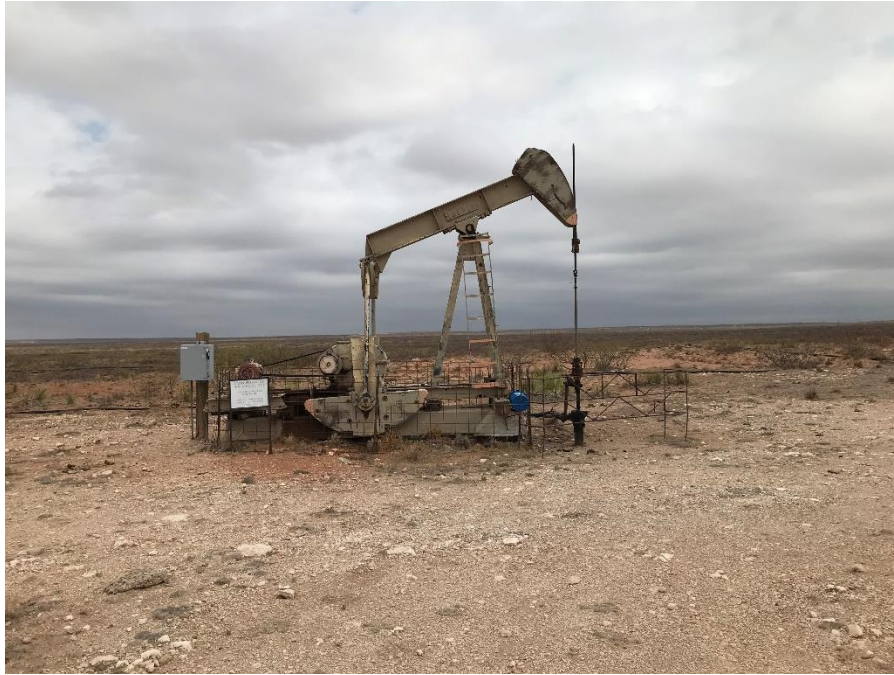
**Photo 5:** Cato San Andres Unit Well #005 viewed facing north approximately (NW4/SW4, section 02, T08S, R30E).

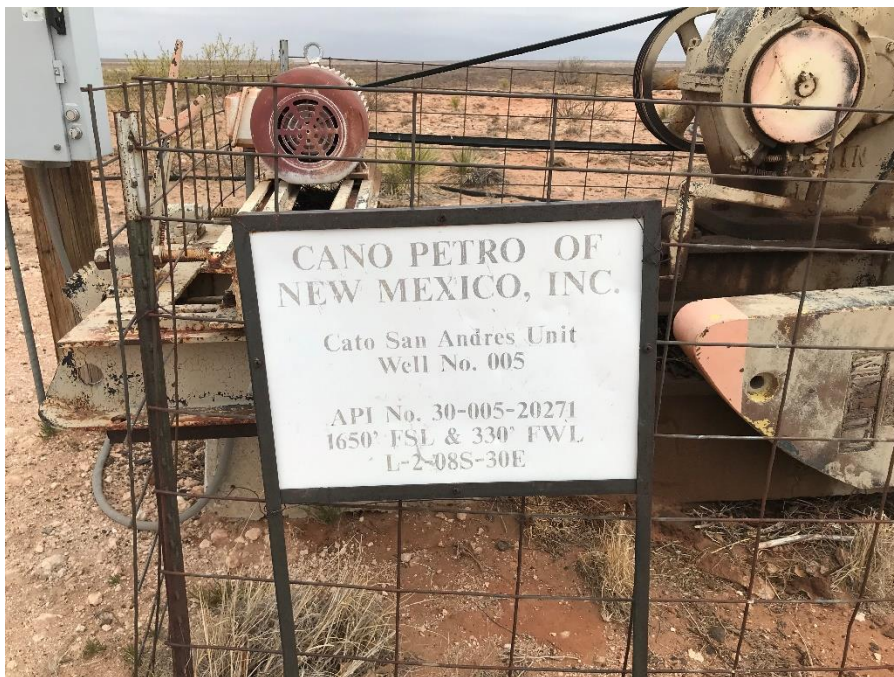
**Photo 6:** Close up view of sign identifying the well site.

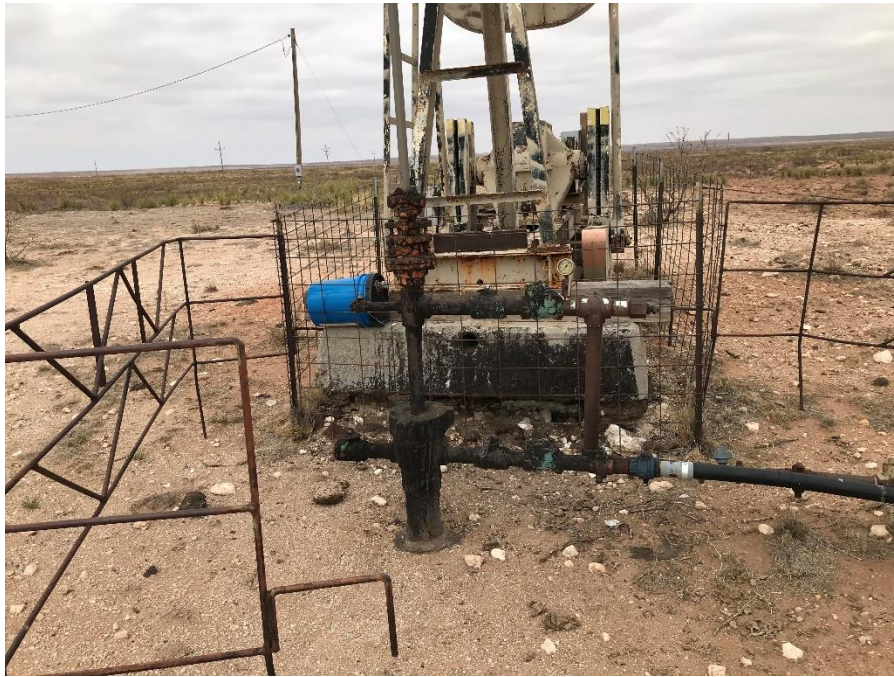
**Photo 7:** Close up view of the wellhead at the Cato San Andres Unit Well #005 (NW4/SW4, section 02, T08S, R30E).

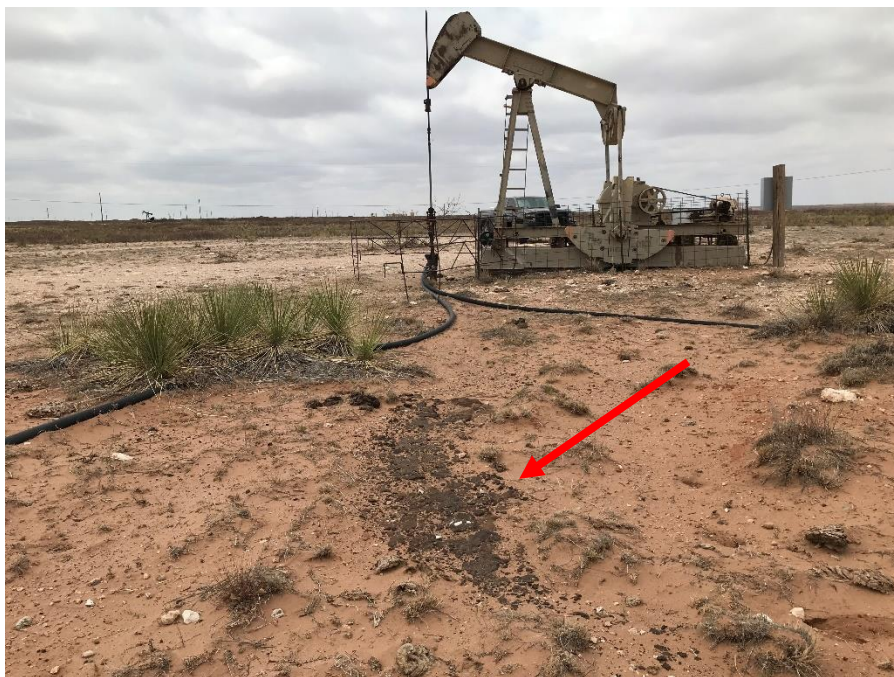
**Photo 8:** Evidence of a prior release observed near the well's flowlines (NW4/SW4, section 02, T08S, R30E).

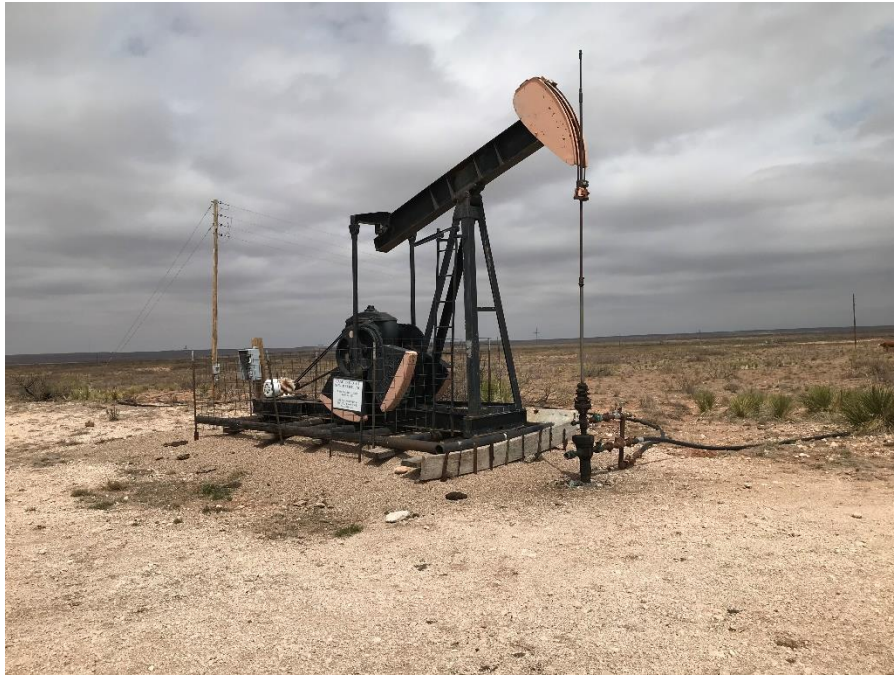
**Photo 9:** Cato San Andres Unit Well #007 viewed facing northwest approximately (SW4/SW4, section 02, T08S, R30E).

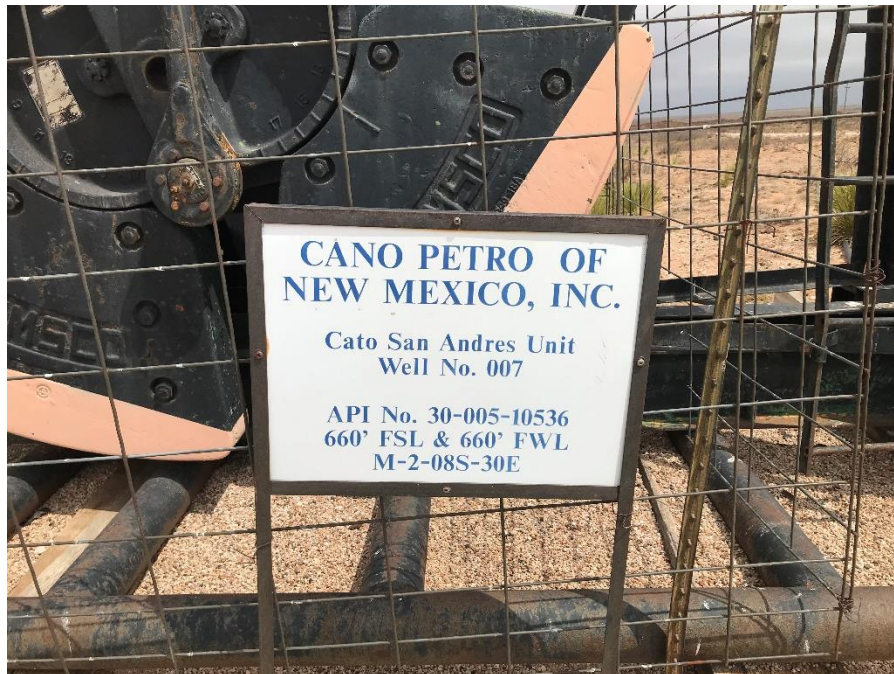
**Photo 10:** Close up view of sign identifying the well site.

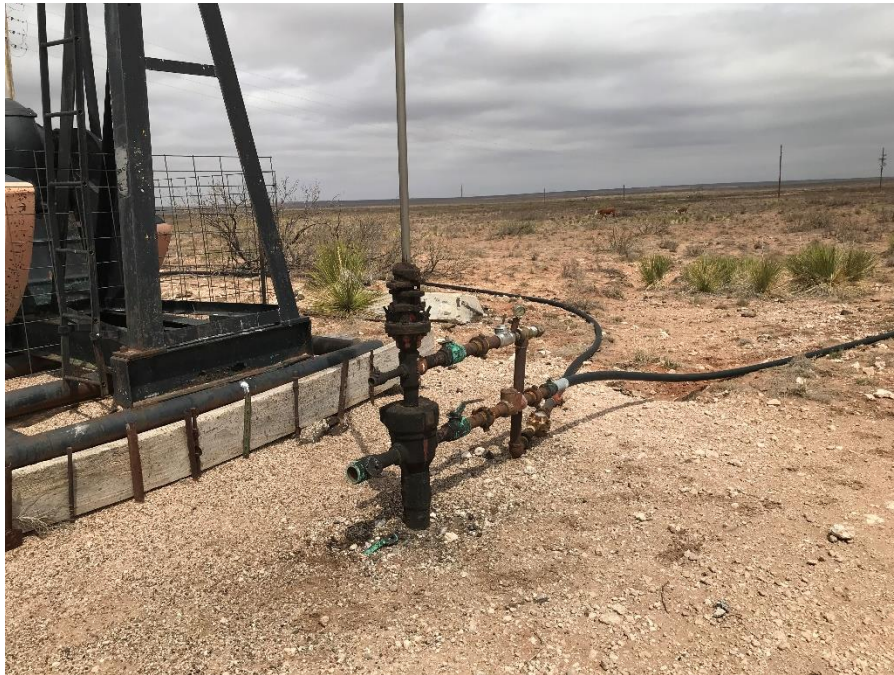
**Photo 11:** Close up view of the wellhead at the Cato San Andres Unit Well #007 (SW4/SW4, section 02, T08S, R30E).

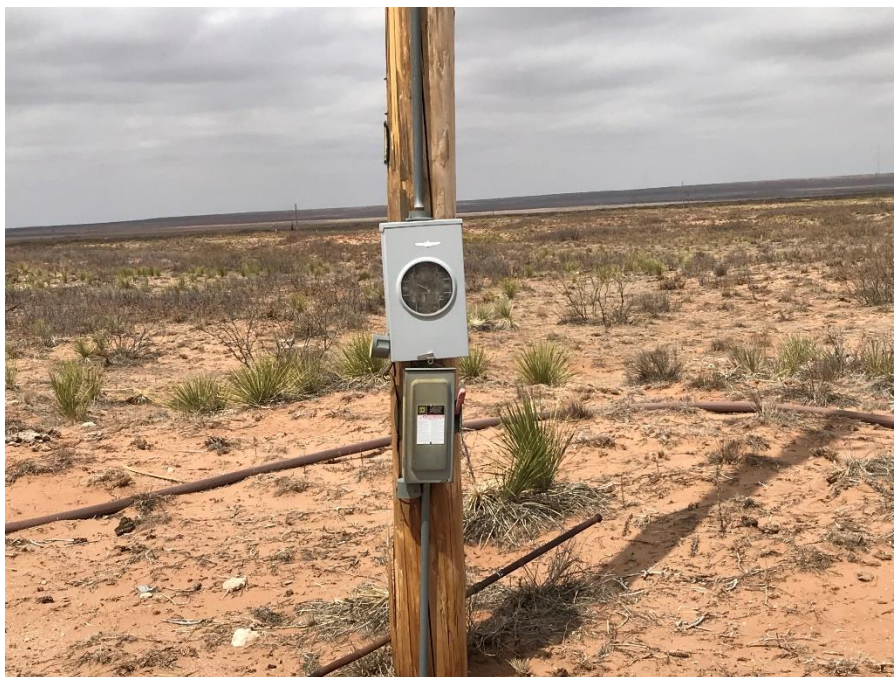
**Photo 12:** Broken electrical meter observed at the Cato San Andres Unit Well #007 (SW4/SW4, section 02, T08S, R30E).

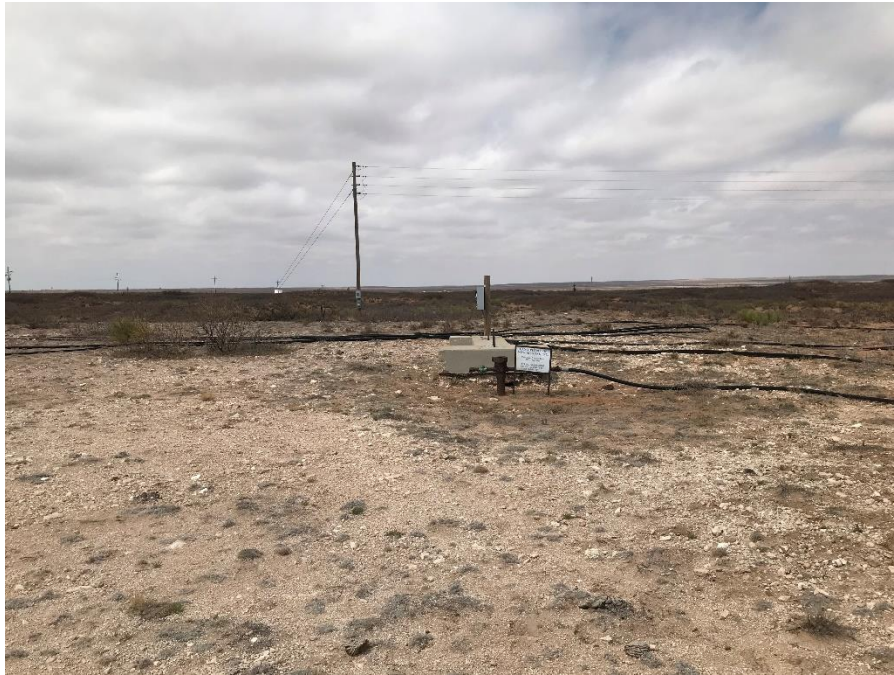
**Photo 13:** Cato San Andres Unit Well #006 viewed facing northwest approximately (SE4/SW4, section 02, T08S, R30E).

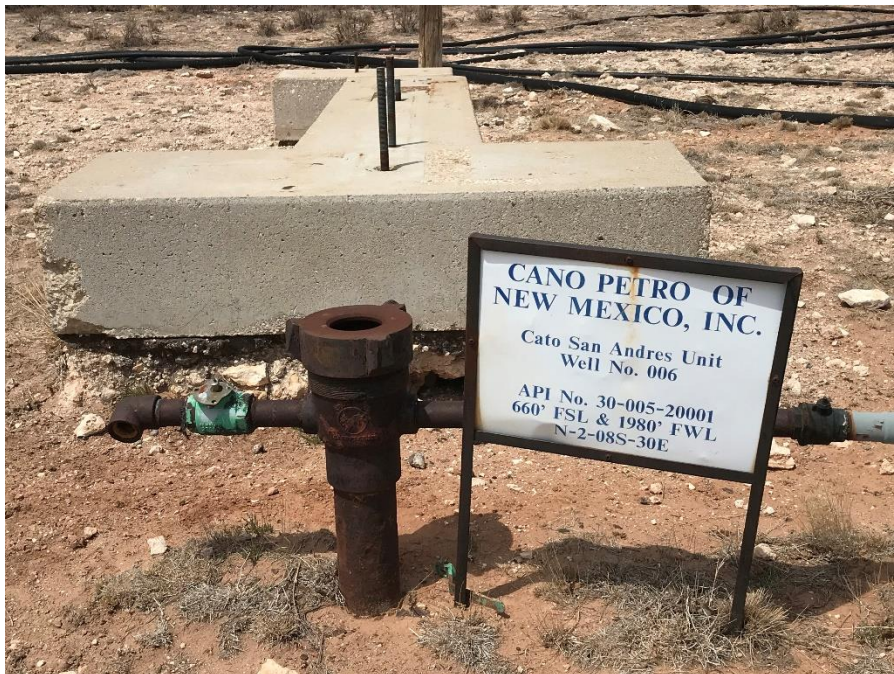
**Photo 14:** Close up view of sign identifying the well site.

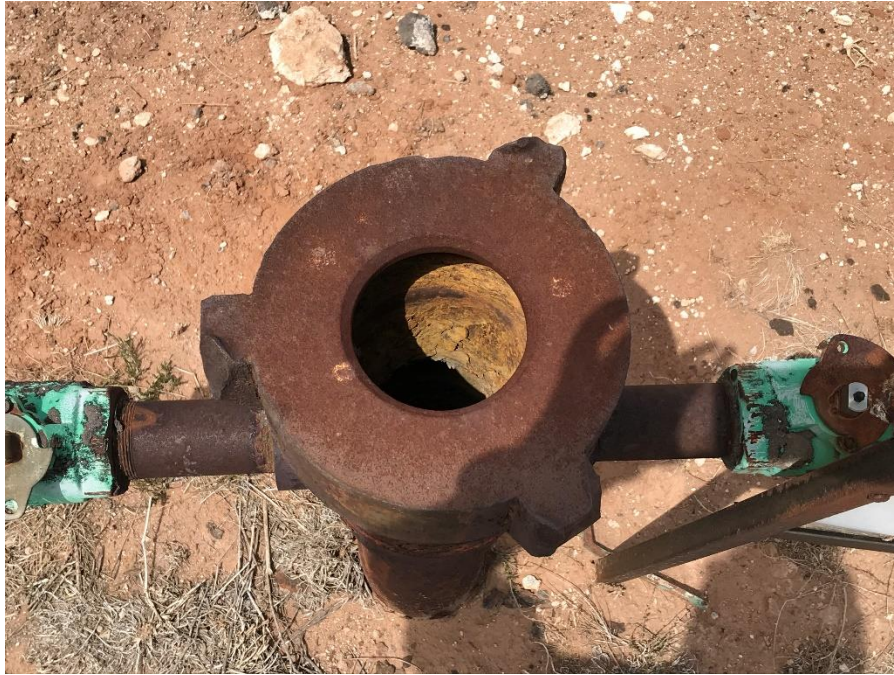
**Photo 15:** Close up view of unplugged/open wellbore at the Cato San Andres Unit Well #006.

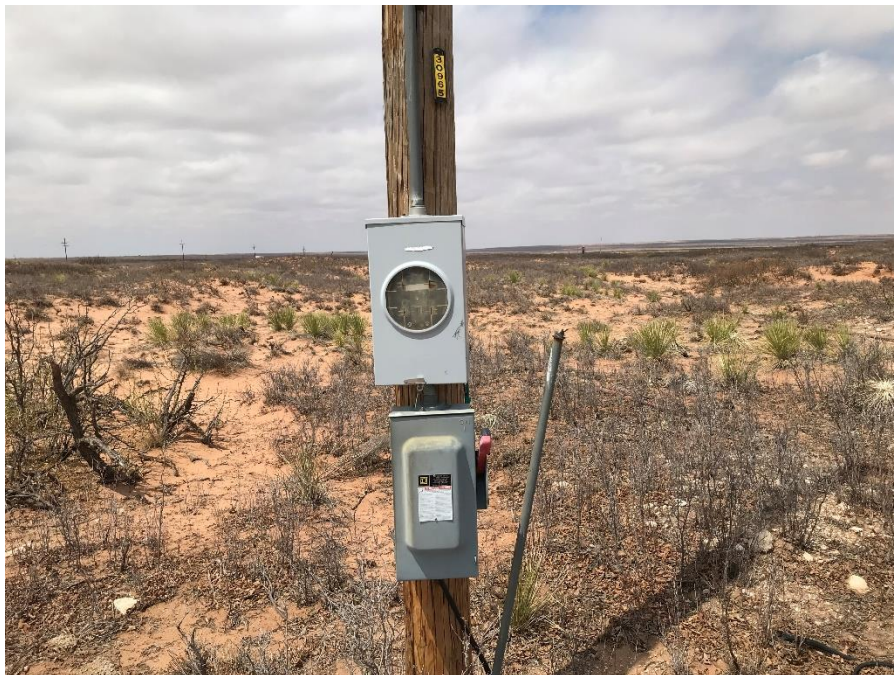
**Photo 16:** Broken electrical meter observed at the Cato San Andres Unit Well #006 (SE4/SW4, section 02, T08S, R30E).

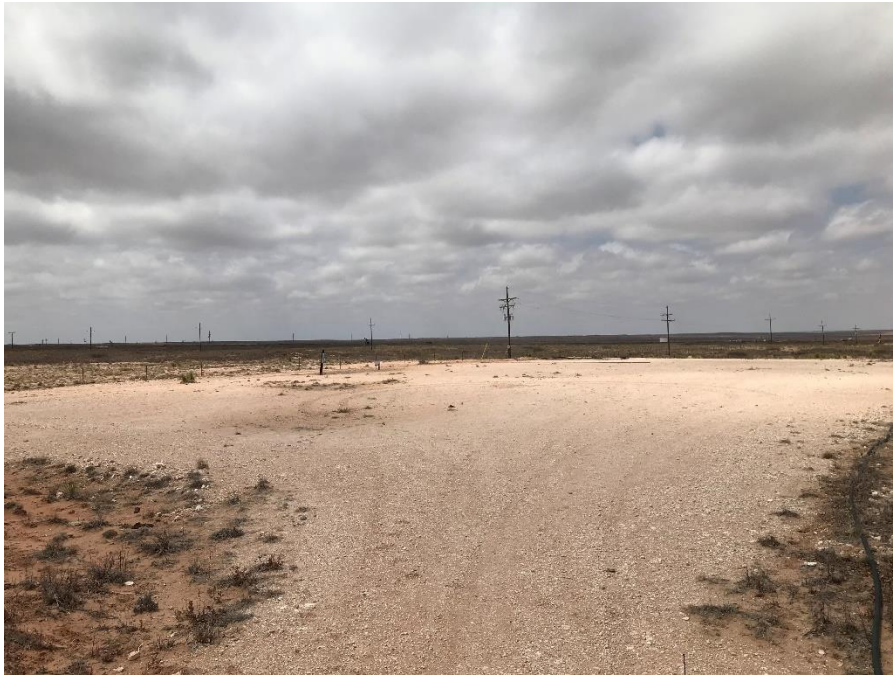
**Photo 17:** Cato San Andres Unit Well #505 viewed facing southwest approximately (SE4/SW4, section 02, T08S, R30E). Note the pad needs to be reclaimed.

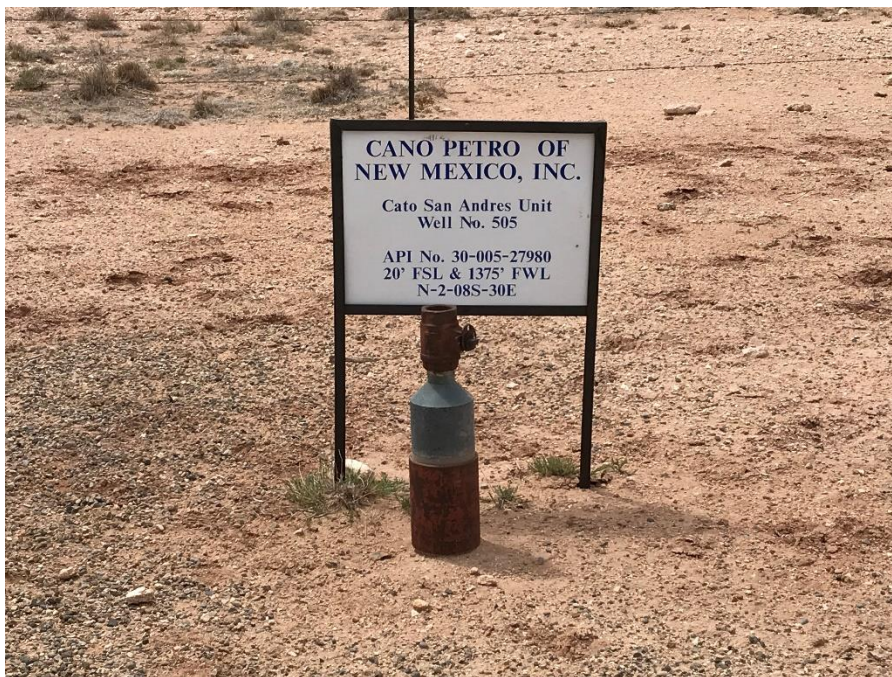
**Photo 18:** Close up view of well signage and unplugged/open wellbore.

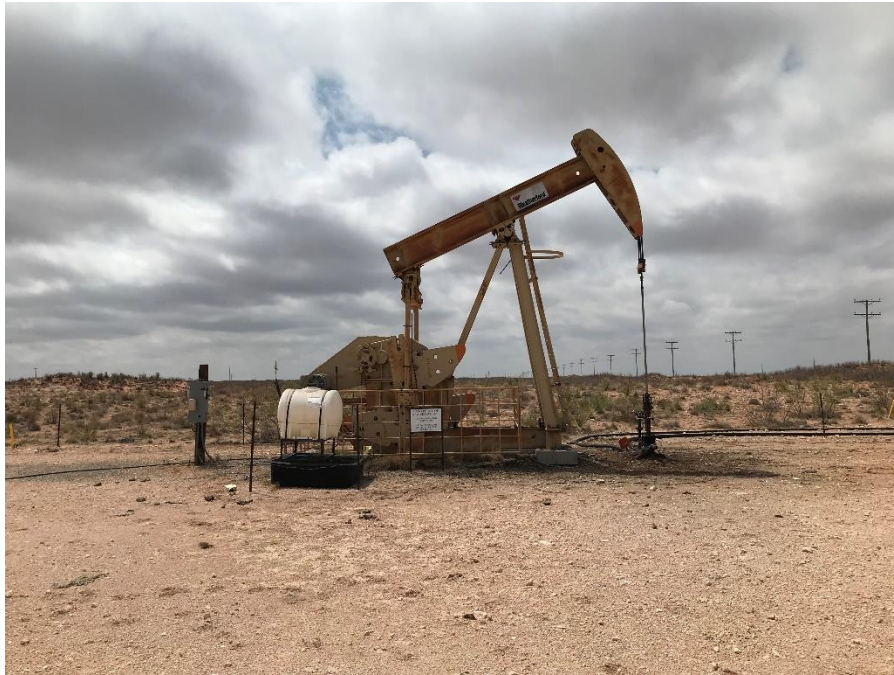
**Photo 19:** Cato San Andres Unit Well #506 viewed facing south approximately (SW4/SE4, section 02, T08S, R30E).

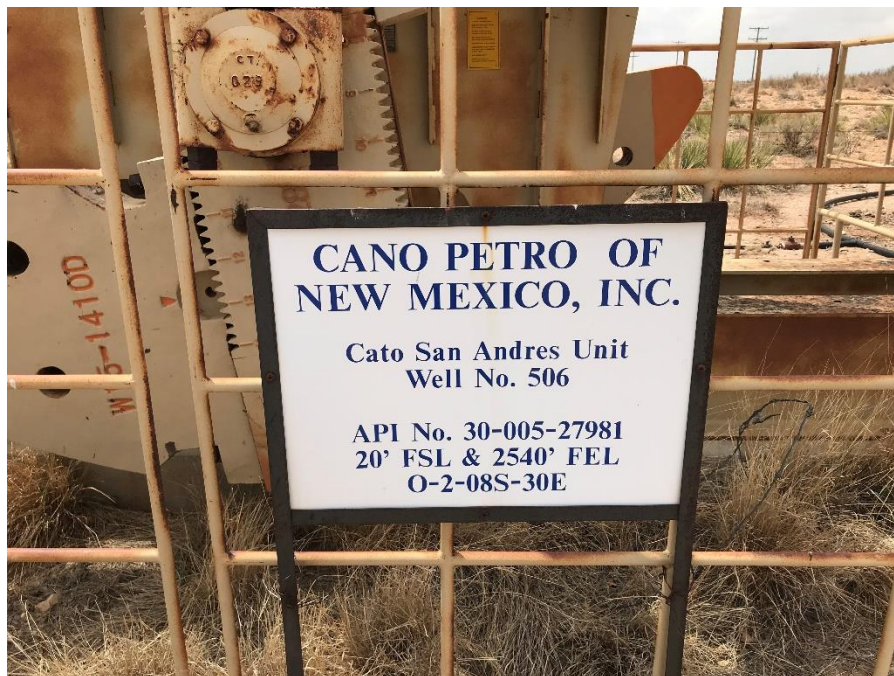
**Photo 20:** Close up view of sign identifying the site.

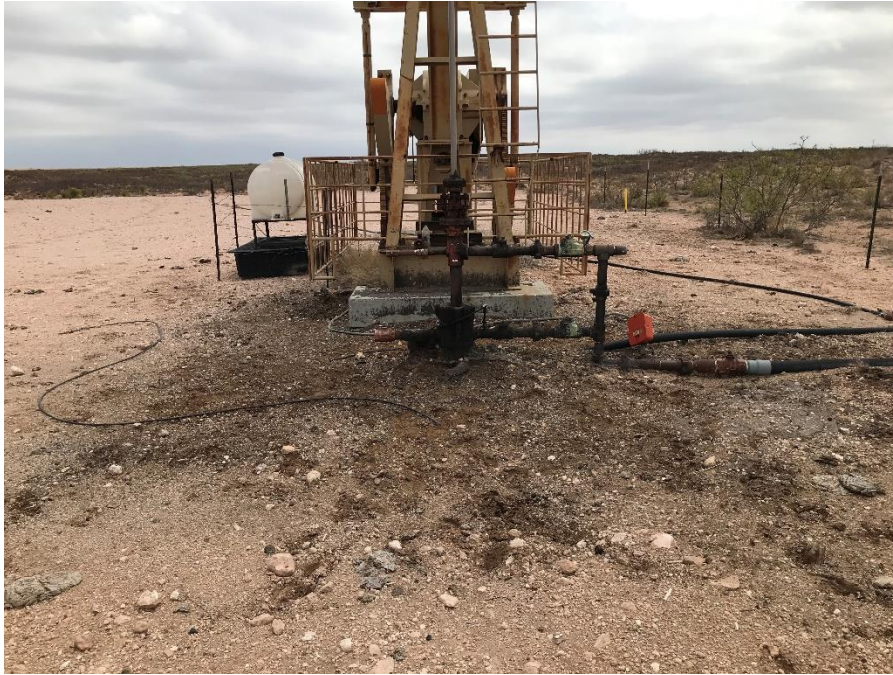
**Photo 21:** Close up view of the wellhead at the Cato San Andres Unit Well #506 (SW4/SE4, section 02, T08S, R30E).

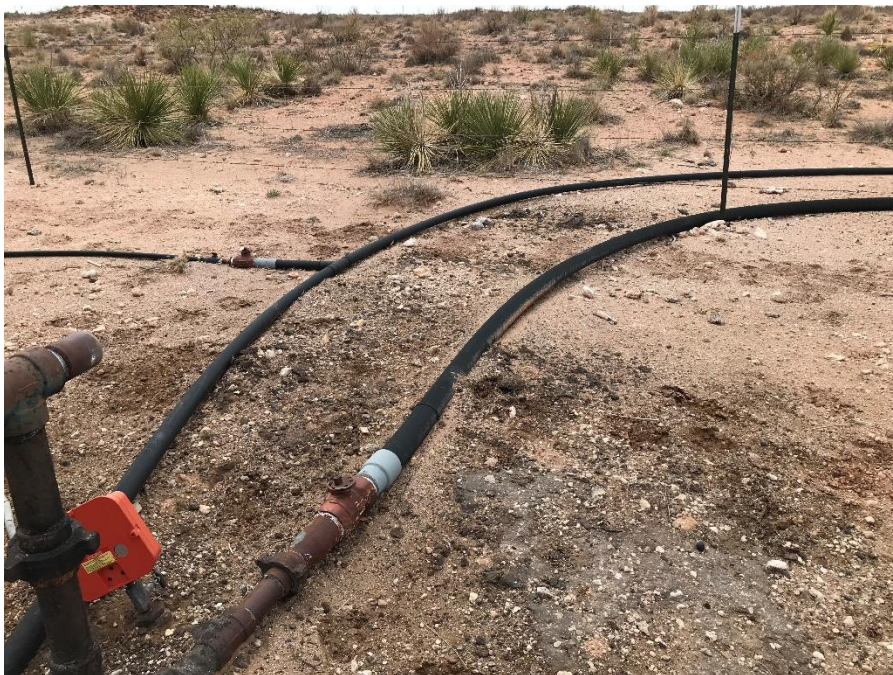
**Photo 22:** Asphaltine residue observed at the Cato San Andres Unit Well #506 (SW4/SE4, section 02, T08S, R30E).

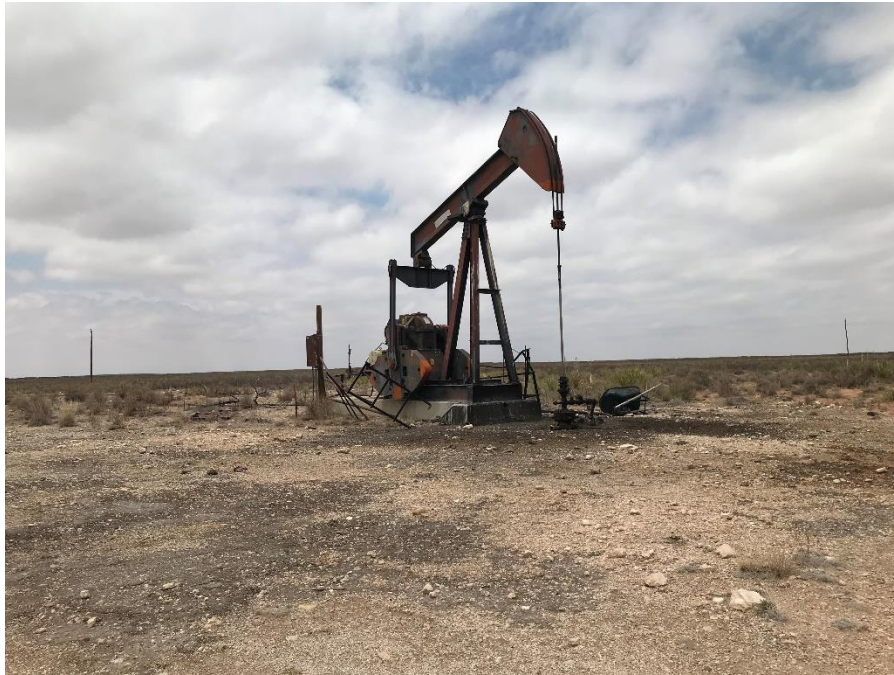
**Photo 23:** State 32 #005 well viewed facing northwest approximately (NE4/NW4, section 32, T07S, R31E). Note the staining present on the pad.

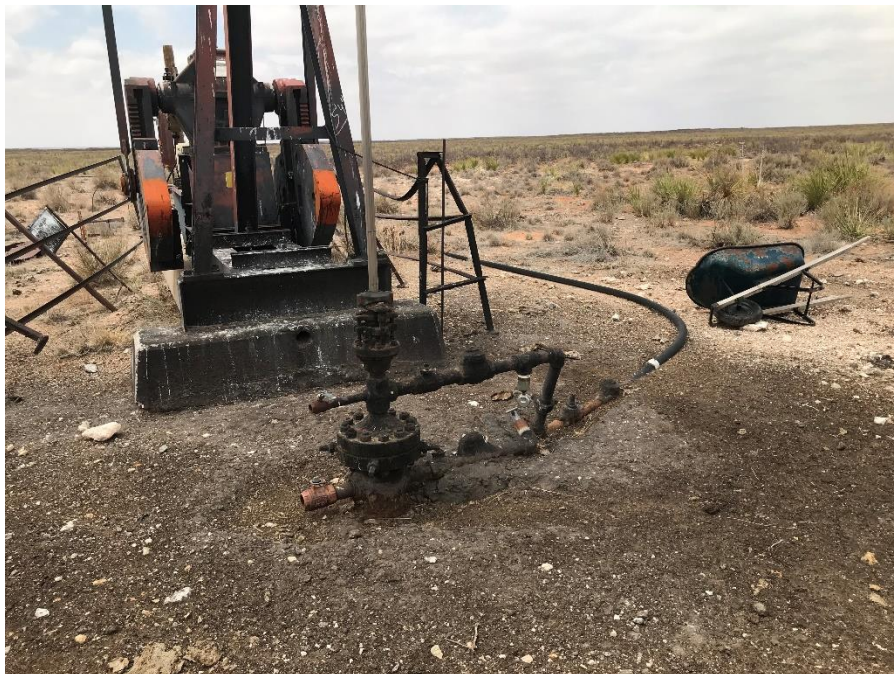
**Photo 24:** Close up view of the State 32 #005 wellhead, staining present.

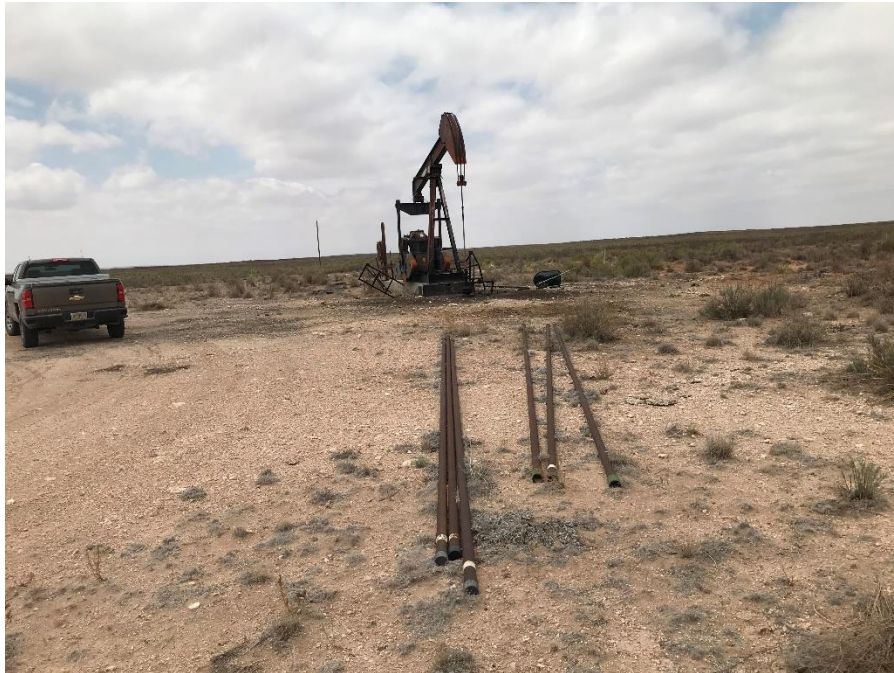
**Photo 25:** Scrap pipe observed on the well pad.

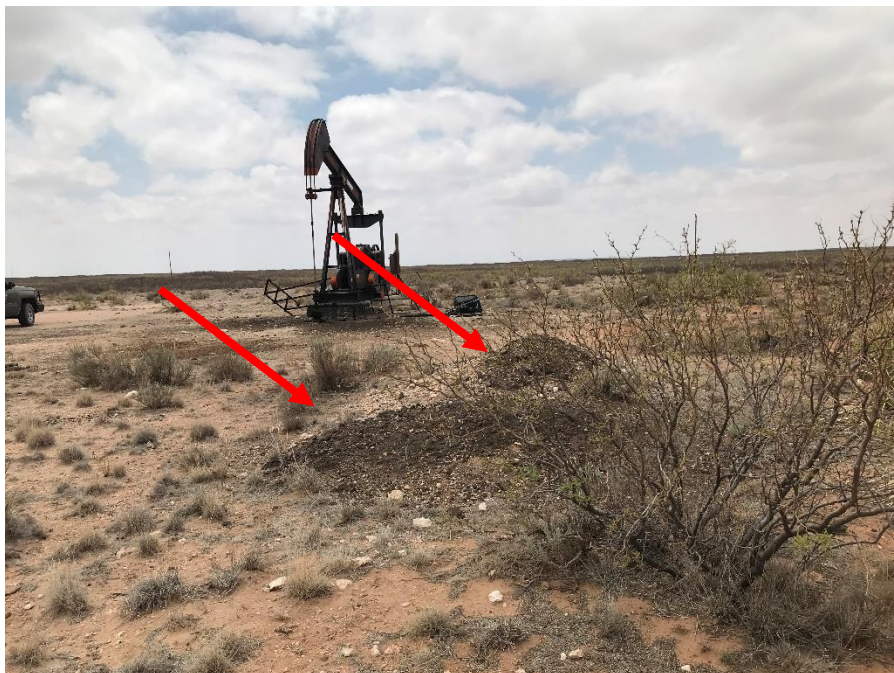
**Photo 26:** Two small stockpiles of contaminated soil near the northeast corner of the pad (no liner or secondary containment beneath soil).

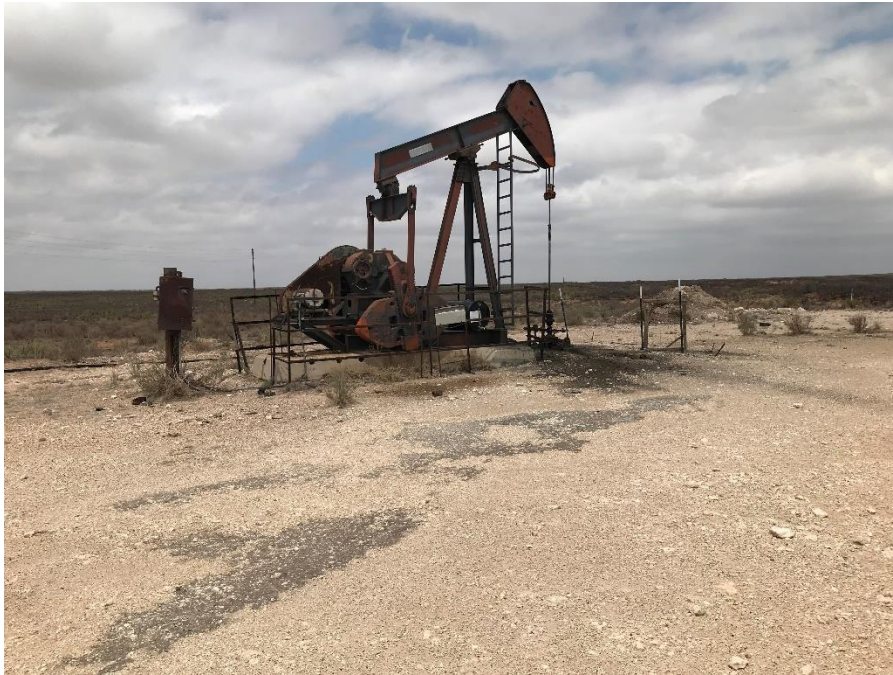
**Photo 27:** State 32 #003 well viewed facing northwest approximately (NE4/NE4, section 32, T07S, R31E). Note the staining present on the pad.

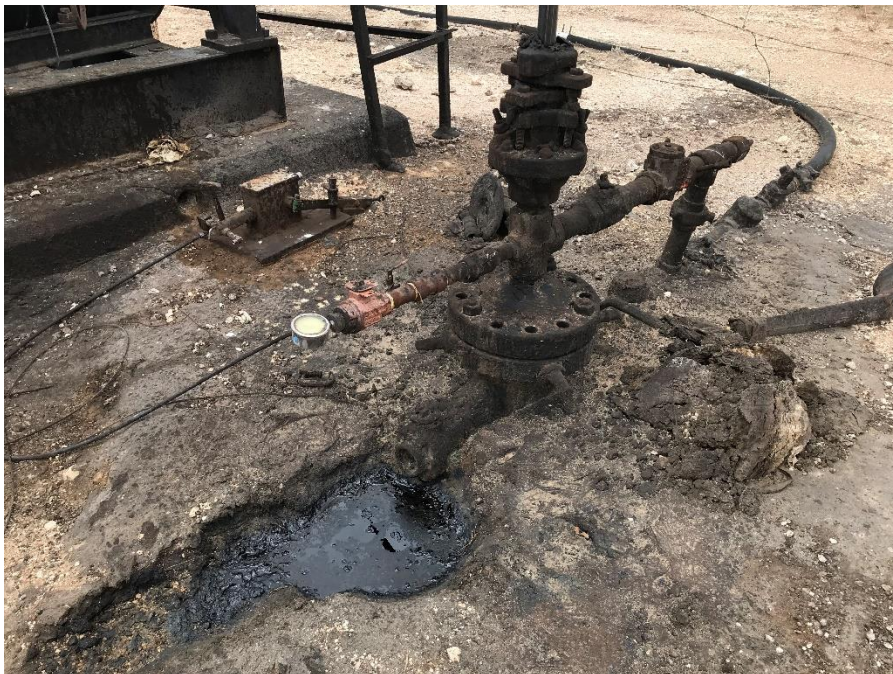
**Photo 28:** Close up view of the State 32 #003 wellhead, staining present.

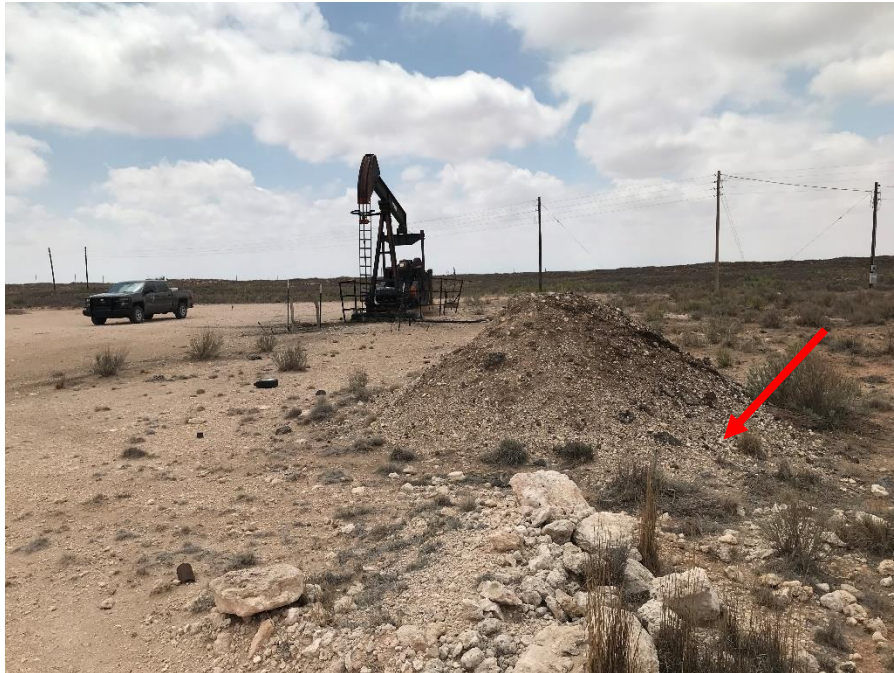
**Photo 29:** One small stockpile of contaminated soil near the pumpjack (no liner or secondary containment beneath soil).

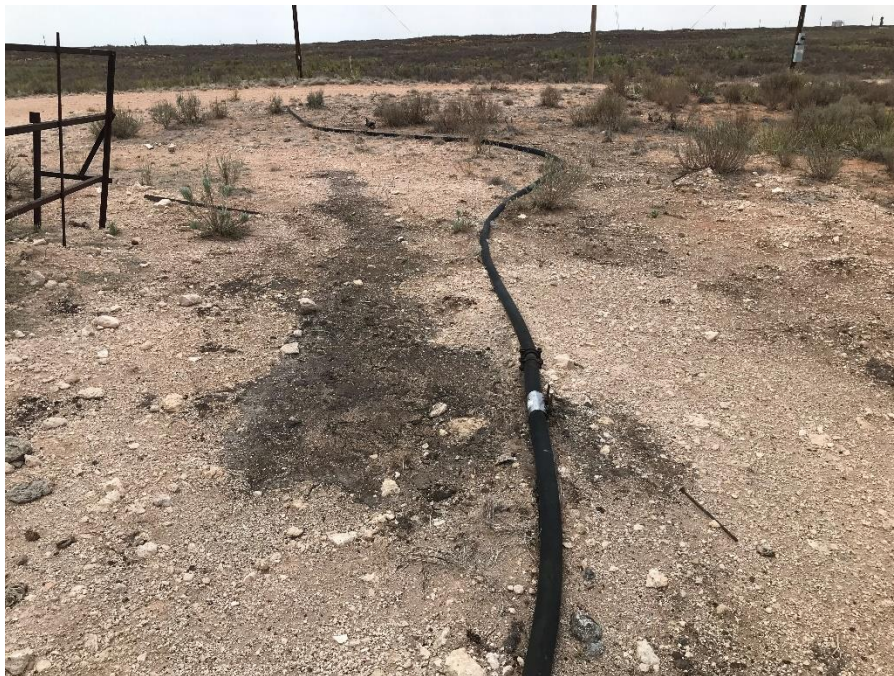
**Photo 30:** Flowline patch, evidence of prior leak on this pipeline.

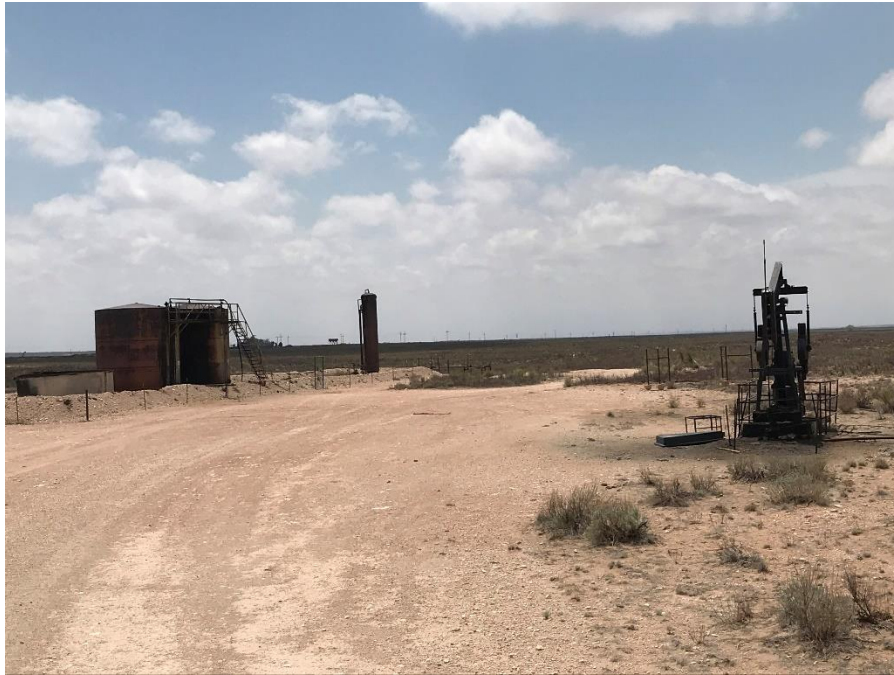
**Photo 31:** State 32 #002 well and tank battery viewed facing southwest approximately (NW4/SE4, section 32, T07S, R31E).

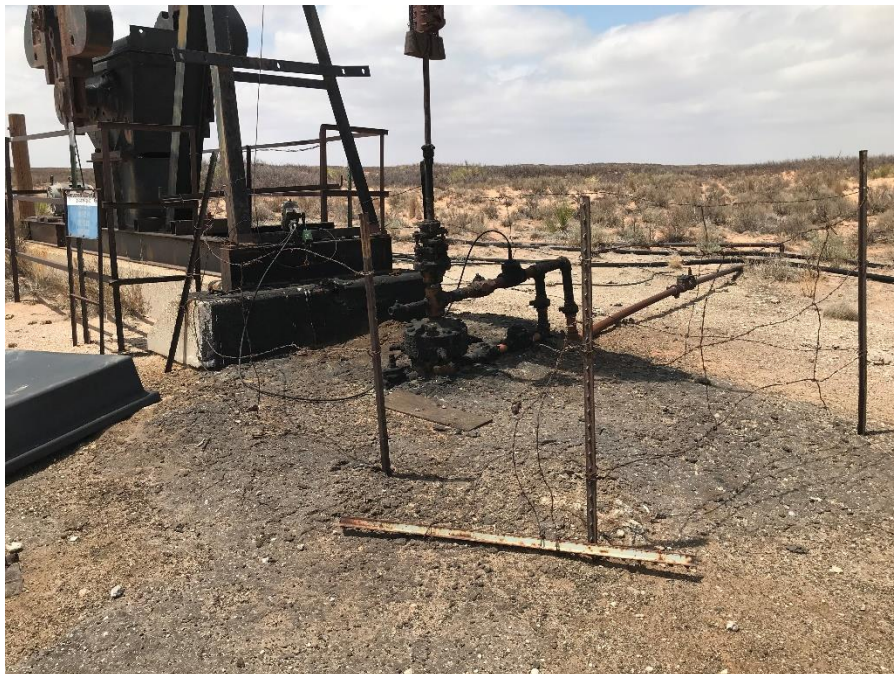
**Photo 32:** State 32 #002 wellhead, staining present.

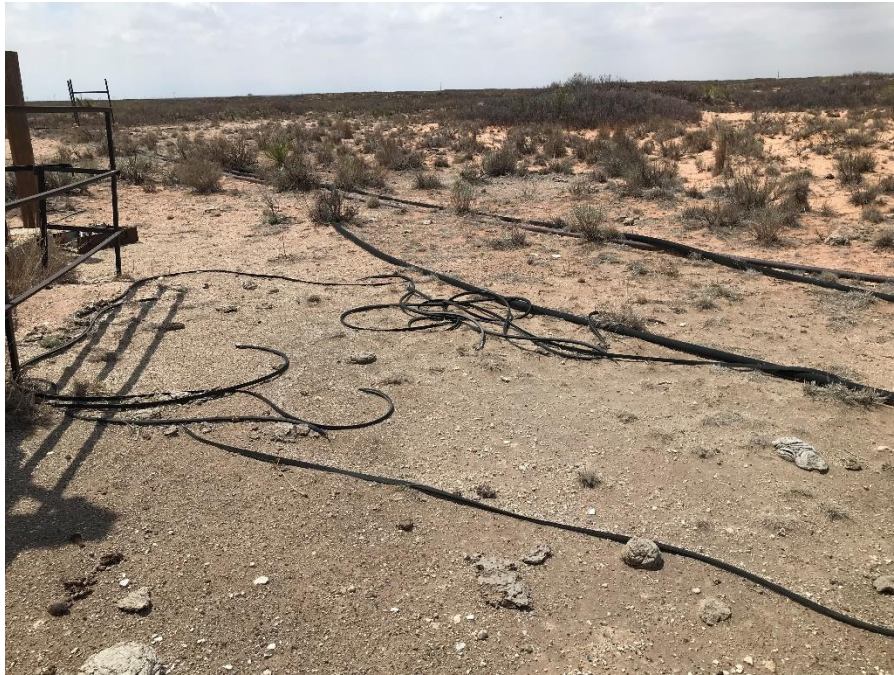
**Photo 33:** Trash observed at the well.

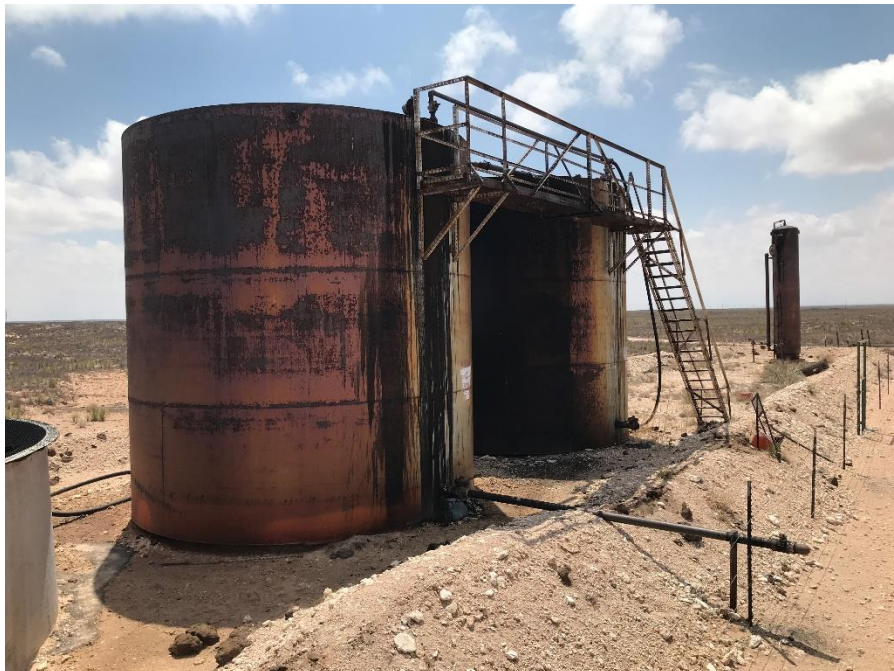
**Photo 34:** State 32 #002 tank battery viewed facing west approximately (NW4/SE4, section 32, T07S, R31E).

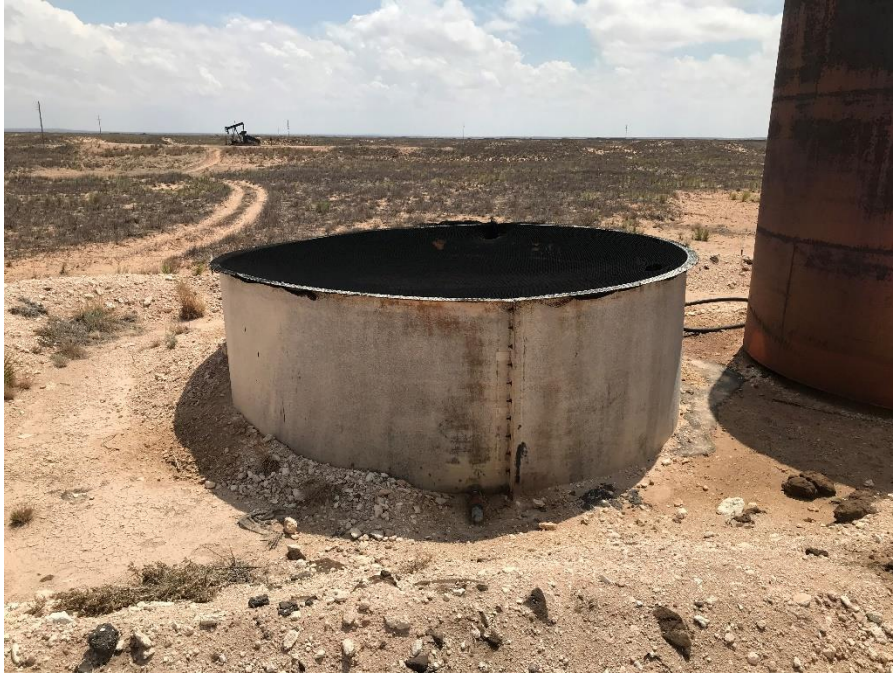
**Photo 35:** Open top fiberglass tank at State 32 #002 tank battery.

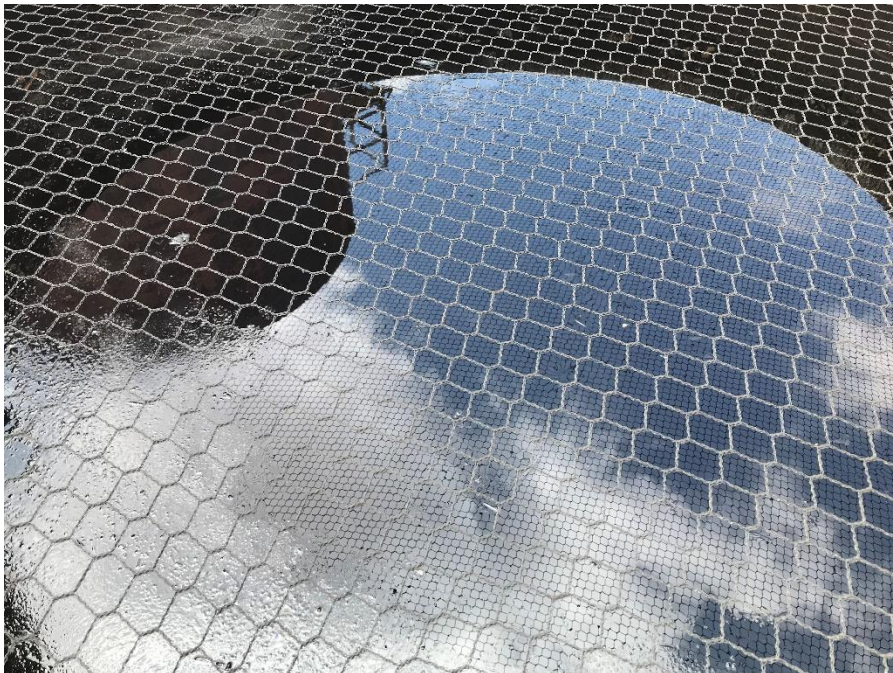
**Photo 36:** View of product remaining in the open top tank.

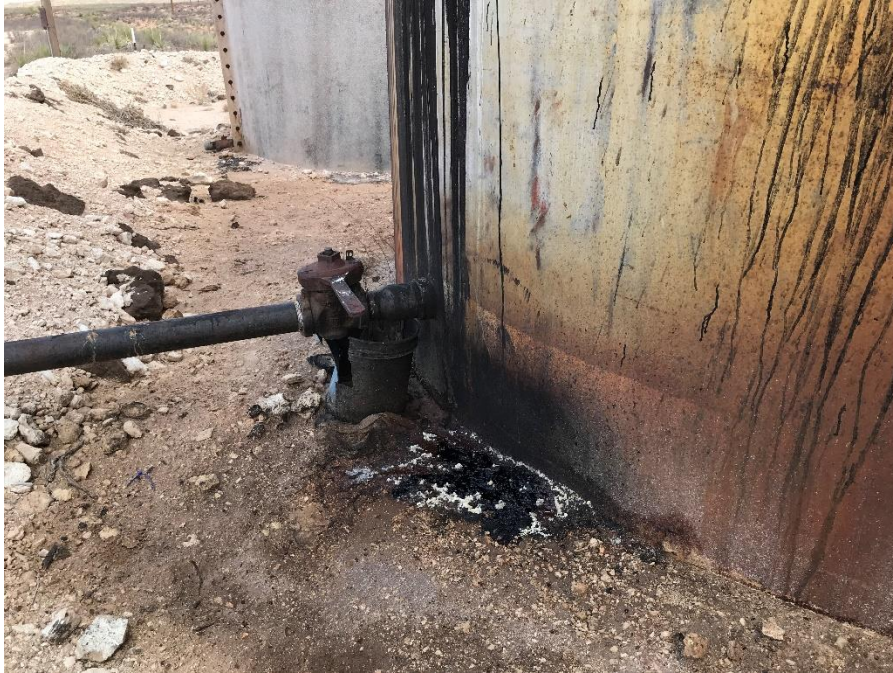
**Photo 37:** Damaged storage tank and staining at the base.
