**EXHIBIT A: PHOTOGRAPHS (API # 30-005-27971)**

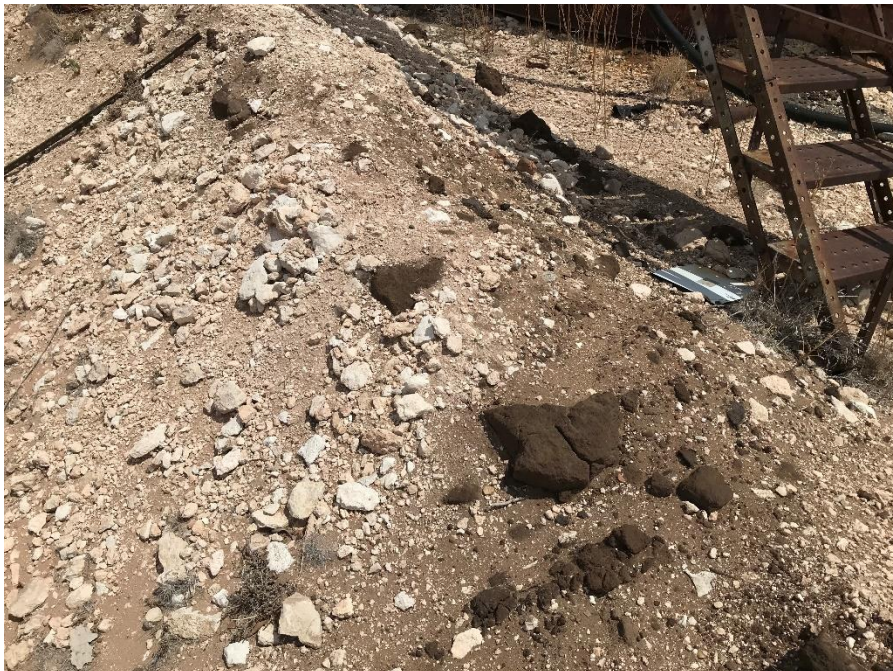
**Photo 38:** Large clumps of contaminated soil in the containment berm structure.

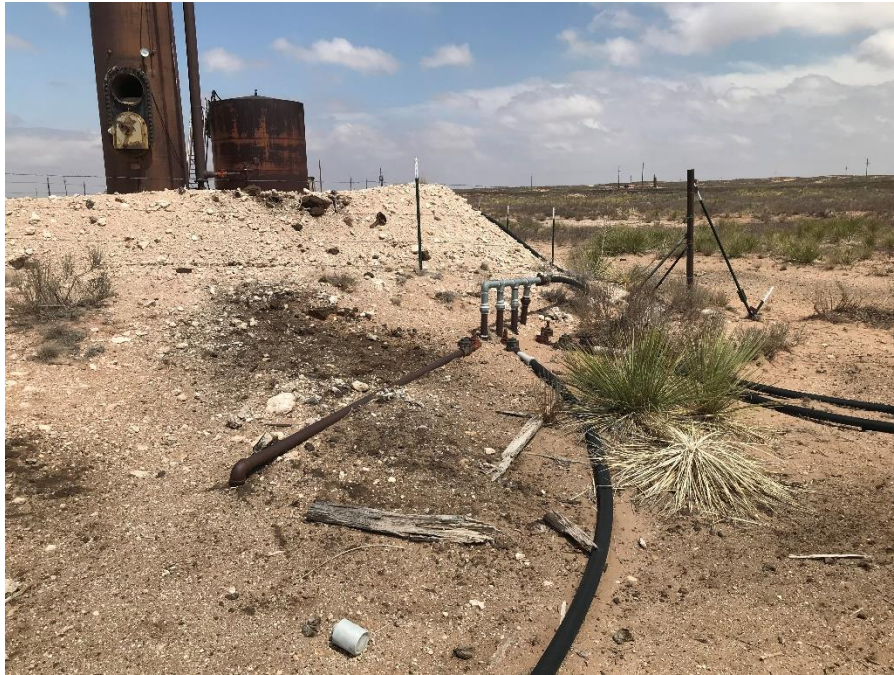
**Photo 39:** Staining observed along the west side of the site.

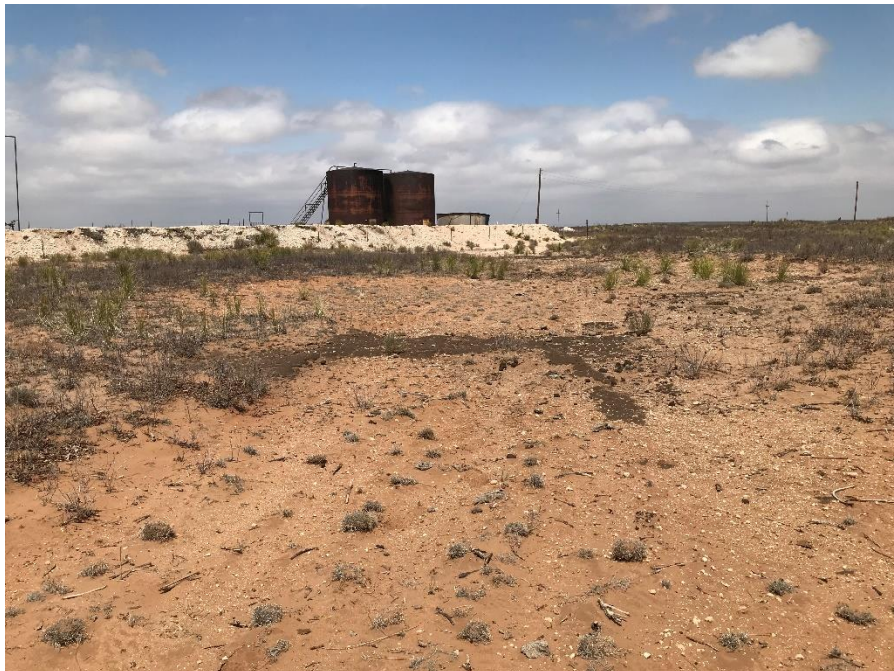
**Photo 40:** Evidence of previous release (bare soil and asphaltine) observed directly south of the tank battery

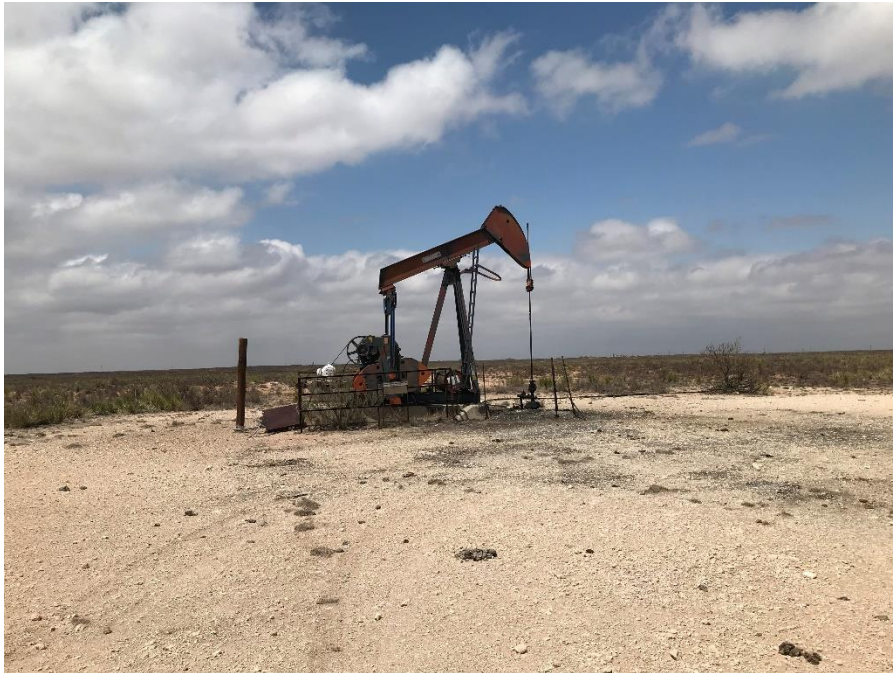
**Photo 41:** State 32 #004 well and tank battery viewed facing northwest approximately (SE4/SW4, section 32, T07S, R31E).

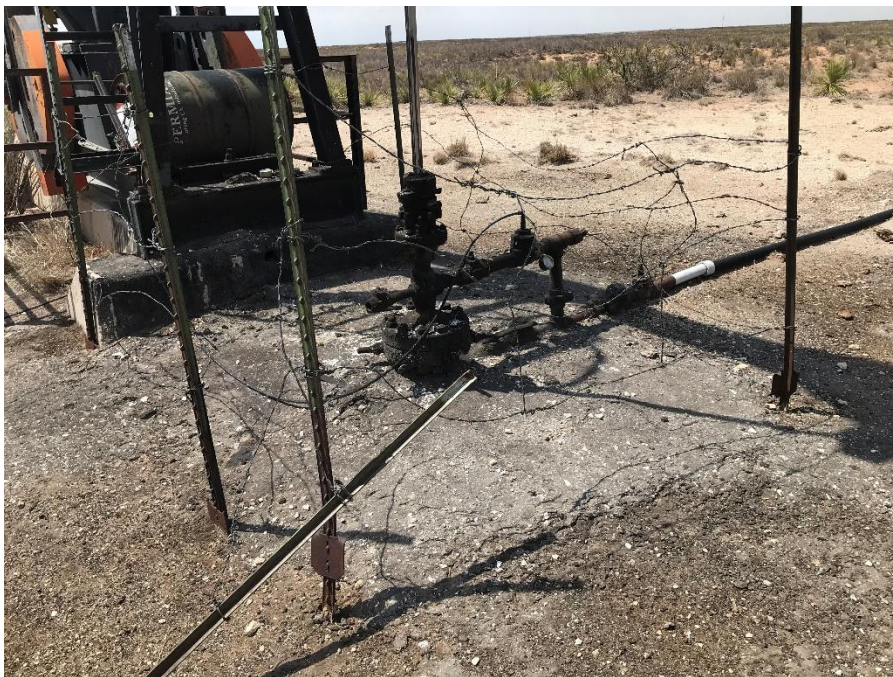
**Photo 42:** Close up view of State 32 #004 wellhead.
