# OIL AND GAS RECLAMATION WORKPLAN GUIDE

This document has been prepared by the New Mexico State Land Office (NMSLO) Environmental Compliance Office (ECO). This document intends to provide detailed guidance related to the preparation of an oil and gas industry-related reclamation plan that will satisfy the requirements outlined in NMSLO leases and rules.

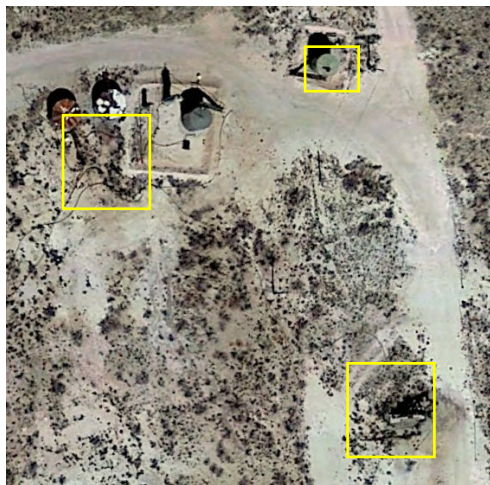
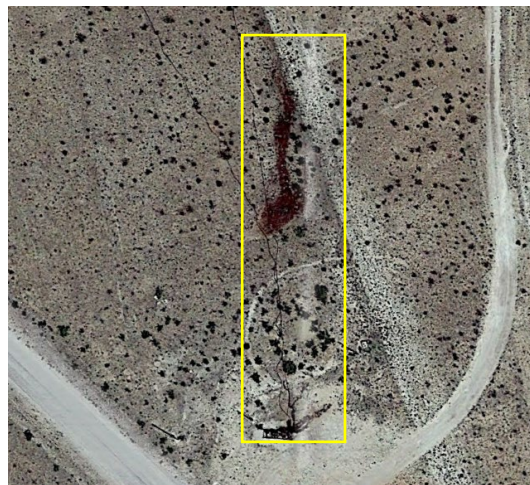
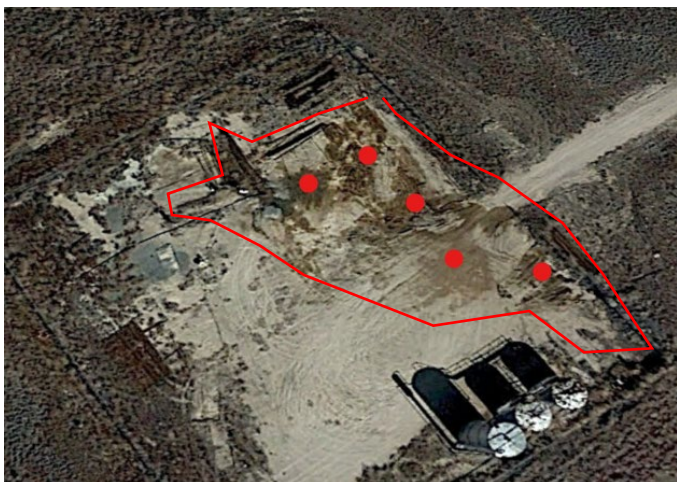
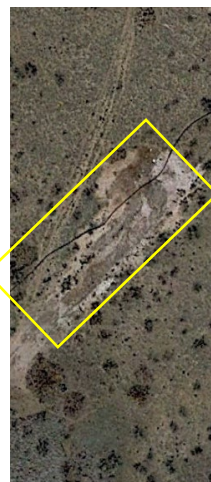
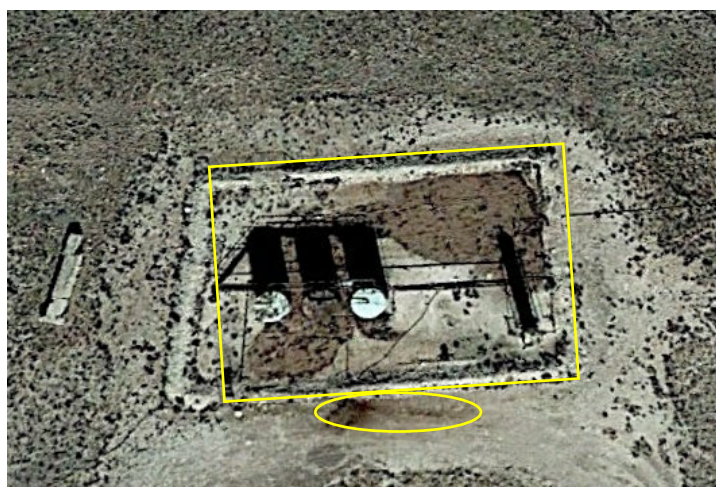
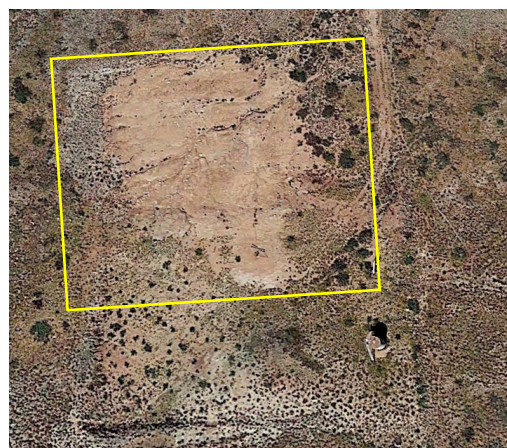
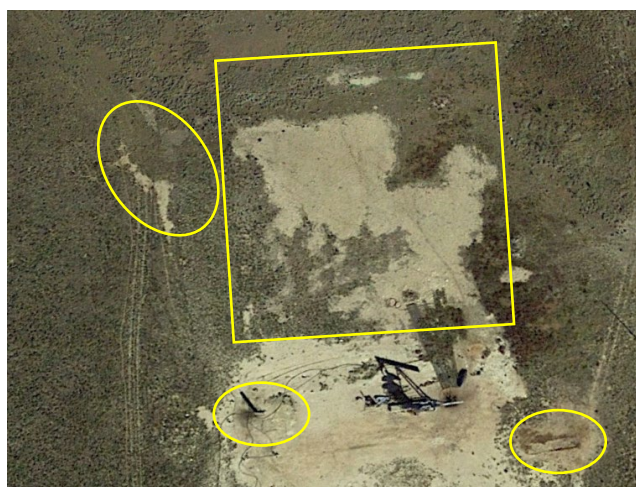
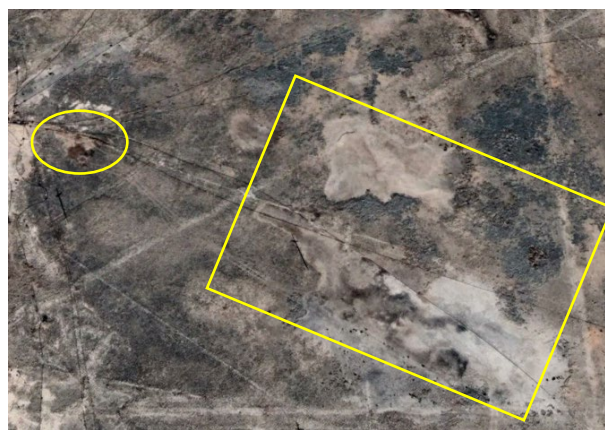
4. Provide photographic or aerial imagery descriptions of historical areas of concern that will require assessment and delineation and possible reclamation. Include assessment sample points where applicable. The following are example images that document areas of concern:

- A review of historical aerals identified surface staining from a potential release surrounding the wellhead in 1996 and in proximity to the tank battery in 2014. This area of concern will be assessed/delineated. A delineation plan will be submitted to [eco@slo.state.nm.us](mailto:eco@slo.state.nm.us) before proceeding with fieldwork. Additionally, a review of the New Mexico Oil Conservation Division (NMOCD) database identified one historical violation (cRB#) for the remaining ancillary equipment and a lack of wellhead marker post-plugging activities during a routine inspection. The violation has not been resolved. A wellhead marker will be installed during planned reclamation activities.*
